Case Caption: Paul Goodman, et al v. Dillon Transportation, LLC

Equipment Involved: Defendant: 2006 Great Dane Lowboy type Semi-Trailer
VIN: 1GRAA06267B705402
GVWR: 55,000

3.0 General Description:

Cause of the collapse was determined by SLTC to be as a result of the improper seating of the kickstand legs’ wear pad on top of the #2 semi-trailer axle.

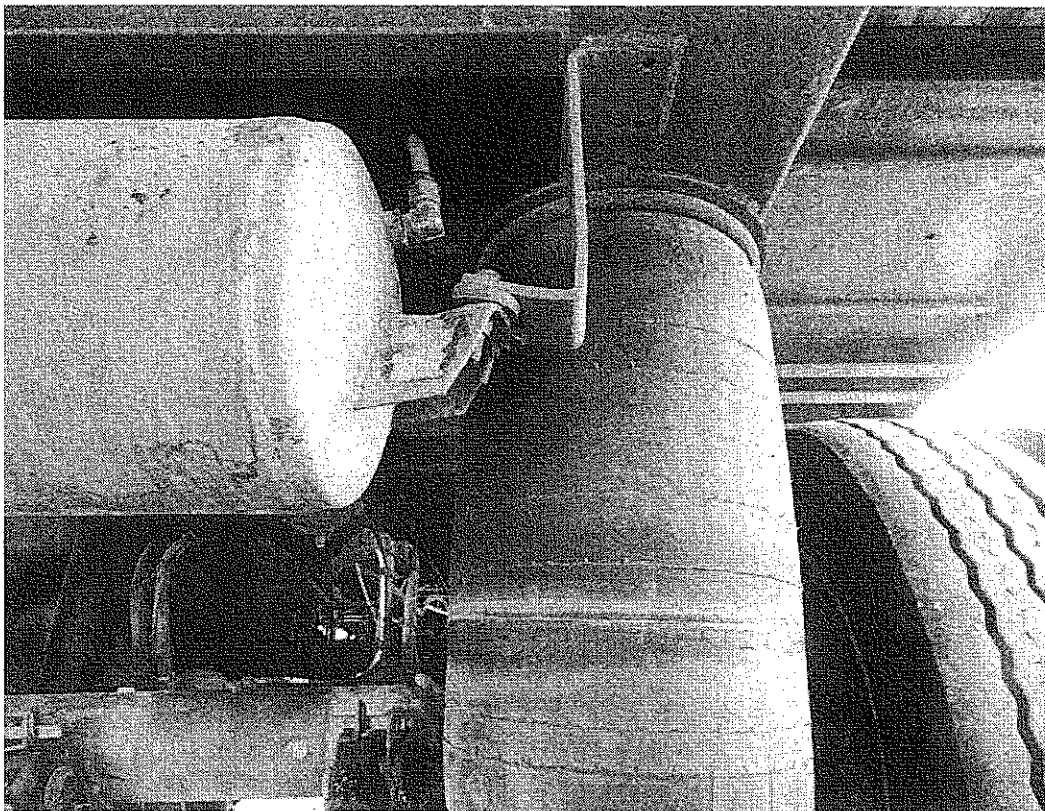
Photo #3

The following photograph demonstrates the same airbag that is utilized, however, fully inflated to elevate the back-end of the semi-trailer to meet the required dock height of which is typical from 3'6" to 4'2".

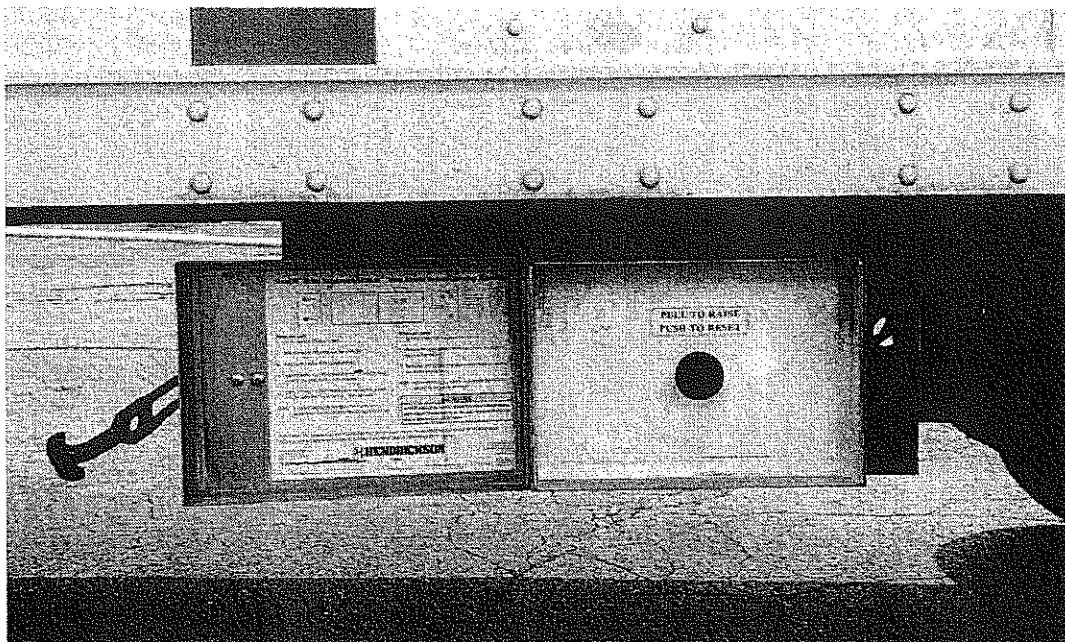
Photo #4

The way the system works is the airbags are inflated, once the CMV operator follows a specific protocol regarding the semi-trailer parking brake system. The system functions by applying the black air valve located on the side of the semi-trailer, driver-side.

Once said valve is applied, after the trailer spring brakes are released the airbags inflate. Said inflation causes the semi-trailer to fully elevate. At the same time this elevation is occurring, there is an air chamber, similar to that of a foundation air brake chamber. The air chamber converts air pressure to mechanical energy.

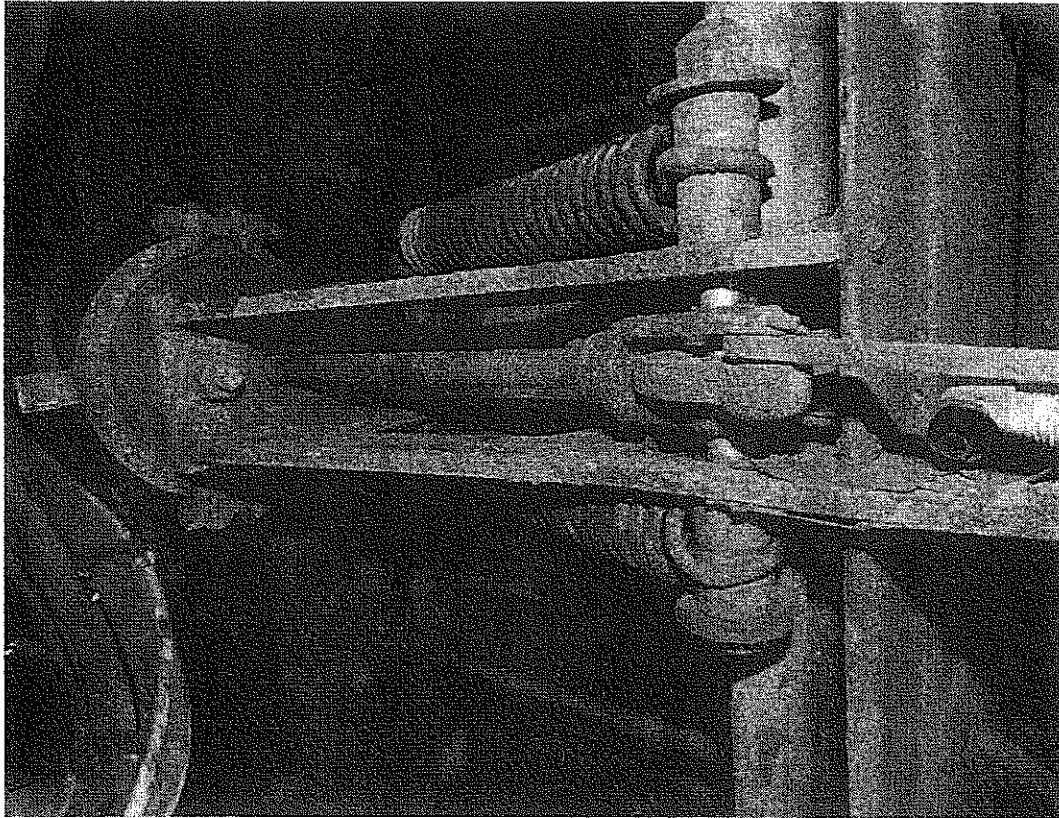
Photo #5

Although it may be somewhat difficult for the layperson's eye to discern exactly what the following photograph demonstrates, it is merely the pushrod coming out of the air chamber that connects to the shaft that ultimately controls the up or down movement of the kickstand legs.

When the CMV driver applies the black air-valve on the side of the semi-trailer, the pushrod is mechanically pushed out of the chamber where the air pressure has been converted to mechanical energy.

The pushrod is attached to the horizontal shaft forming somewhat of a "T". Once this mechanical energy occurs, the horizontal shaft that extends out to the left and right sides from the center of the semi-trailer, the horizontal rod rotates the kickstand legs (left and right) downward. The kickstand legs are attached to either side of the horizontal shaft and rotated onto the axle for support.

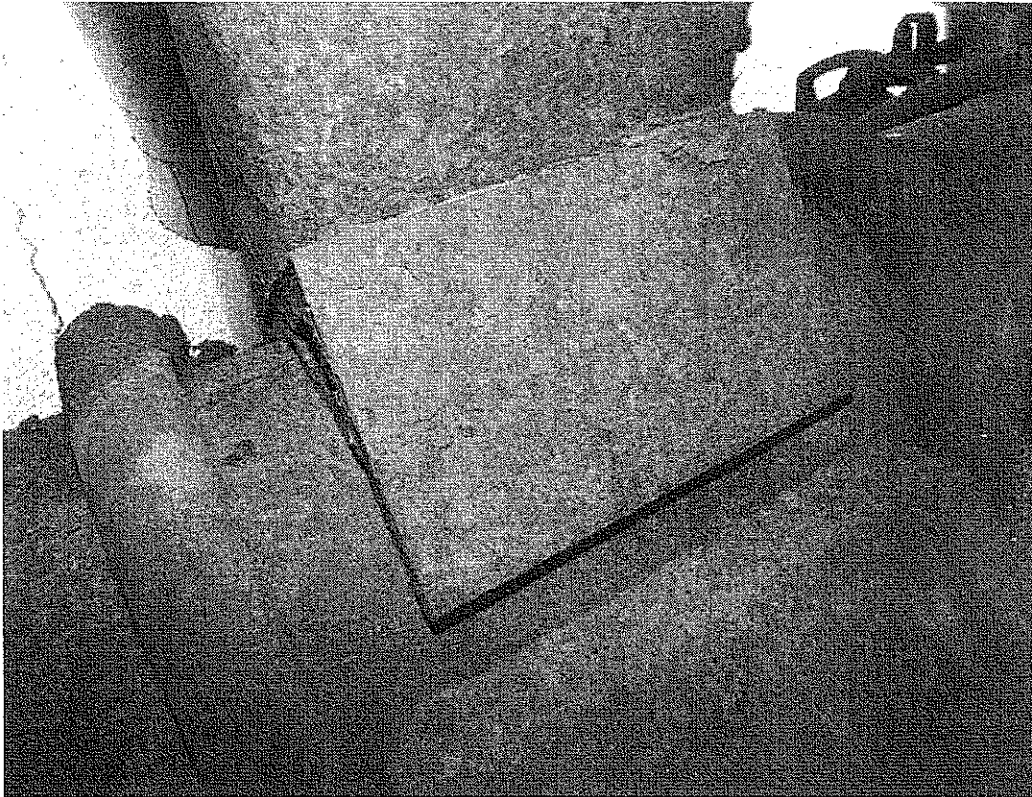
Photo #10

Looking at the reverse angle of the wear pad resting on the axle, the following closer detail photograph is offered:

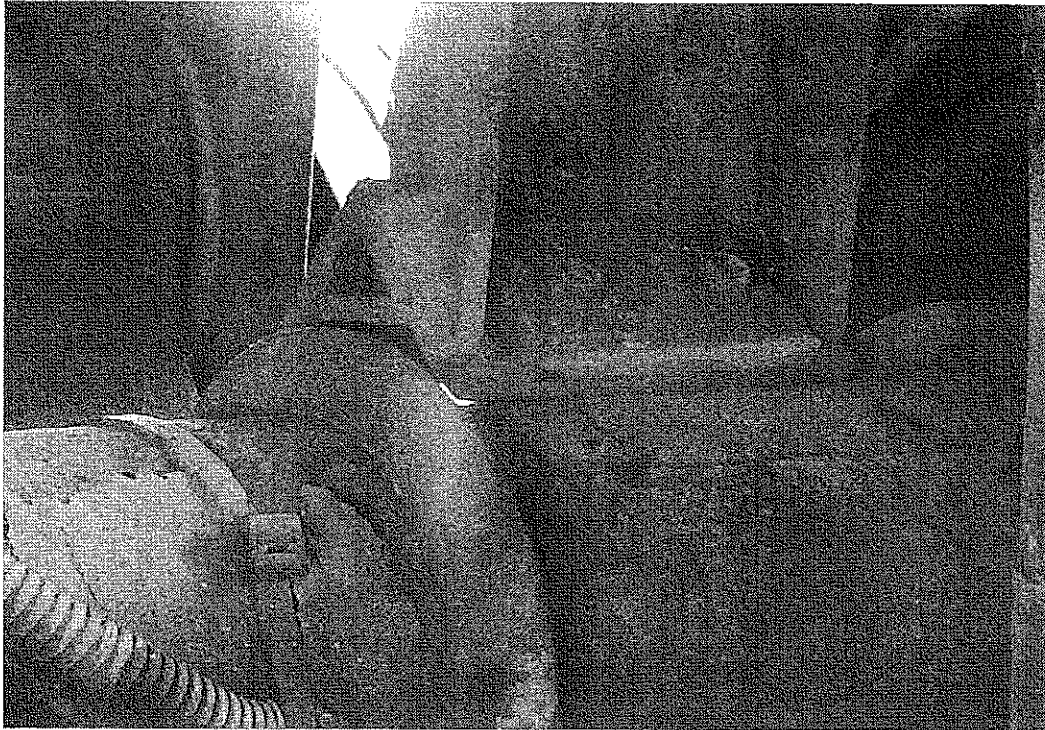
Photo #11

The following photograph points out a few key issues. First, if in fact the wear pads on the bottom of the kickstand legs were not properly seated, as they are in the above photo #9 and #10, there would be a likely collapse of the semi-trailer as the airbags are deflated as part of the Maxi-Lok function. Second, the following photograph #11 clearly demonstrates a kickstand that is not fully seated on the axle. This can be determined based on the position of the kickstand leg; the daylight observed between the wear pad and the axle; and, the difference in oxidation activity where the wear pad rests compared to the adjacent axle surfaces. It must be noted that this condition in photo #11 was intentionally created during the PCI and is not suggested to having been a photo of the actual condition at the time of the incident.

Based on all of the facts of a proper inspection of the kickstand positioning most probably not being performed by Urjiles, and the process of elimination of other factors of causation, it is most probable that the kickstand legs got hung up in a relatively similar position as in photo #11, unbeknownst to Urjiles.

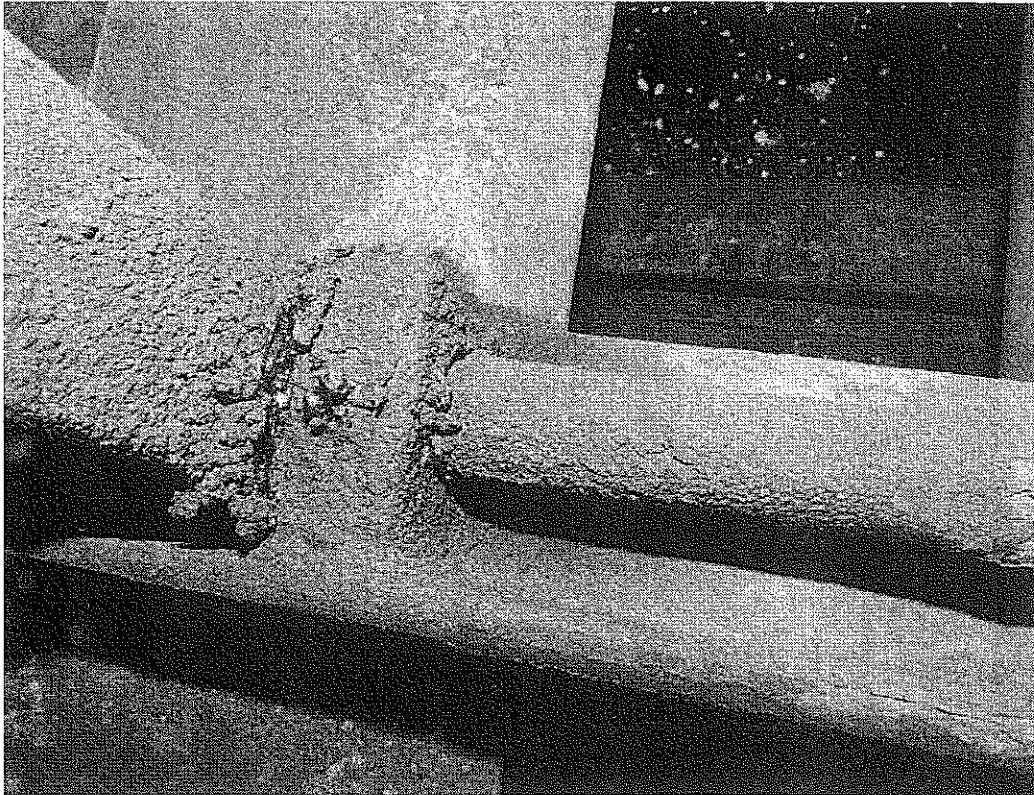
Photo #12

During the PCI it was noted that there was lubrication (grease) on the rod that carries the kickstand legs, however, there was no evidence of fresh grease that would squeeze out of the area intended to be greased, as observed in the following photograph:

Improper grease application, or the failure to grease (lubricate) would result in the intended point of movement that needs lubrication to properly work, it would become hung-up, stiffened or incapable of its full action required. In the absence of lubrication, friction takes over causing restricted and/or resisted movement.

In this case, it most probably resulted in the kickstand legs from reaching their full required swing into the approximate ninety degree right angle position (referenced to the roadway surface), similar to that of photo #9.

8. It is the undersigned's opinion that Dillon failed in its duty to properly and regularly lubricate their CMV, namely the subject Great Dane semi-trailer's Maxi-Lok pivot point and associated grease fittings.
